Topic: Adjustments

Problem: Flex arm is not properly counter balanced

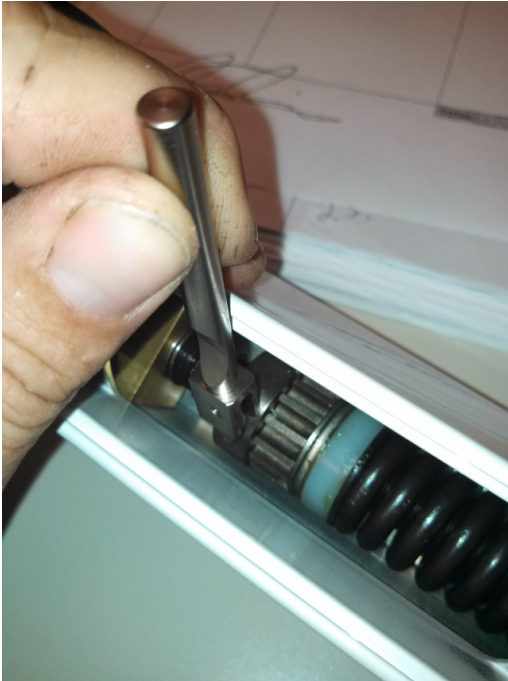
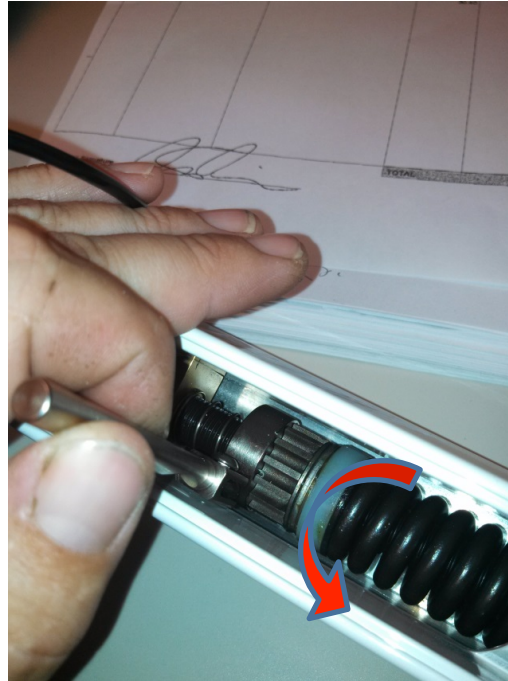
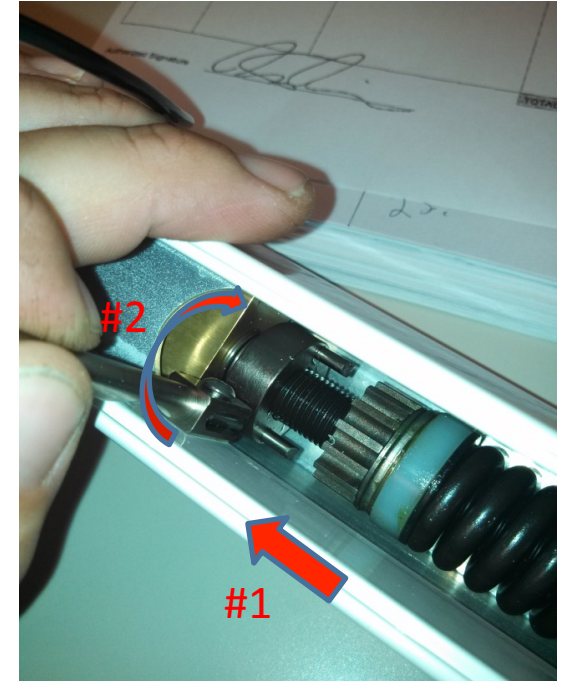
The pictures below show the bottom of the flex arm with the cover slid out of the way for clarity.

To increase tension - Turn the lever attached inside the flex arm in the direction indicated. Then slide it free of the toothed nut, turn it back the opposite direction and re engage it with the toothed nut. Repeat process until the arm is properly tensioned. ****To reduce tension simply turn the toothed nut in the opposite direction****

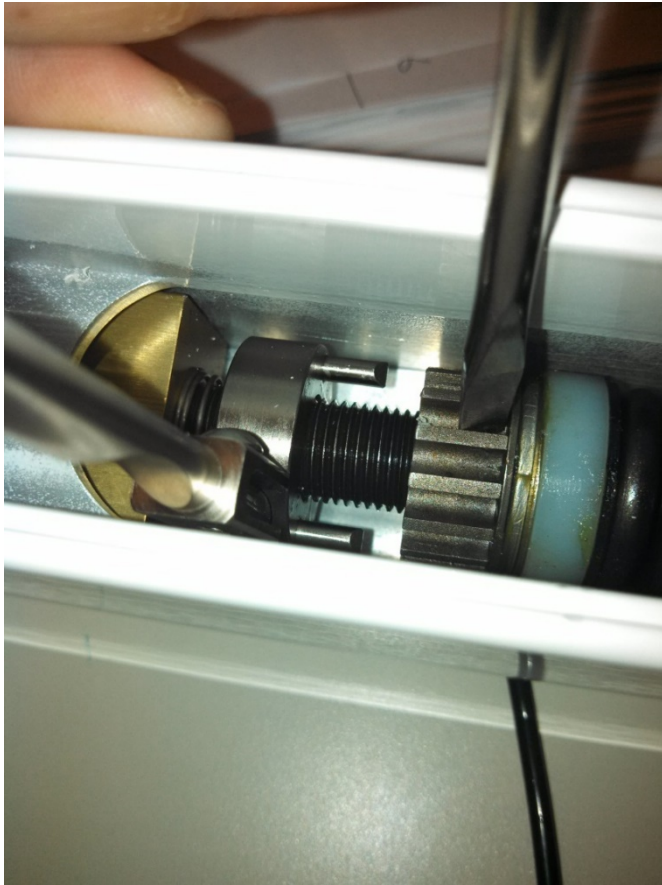
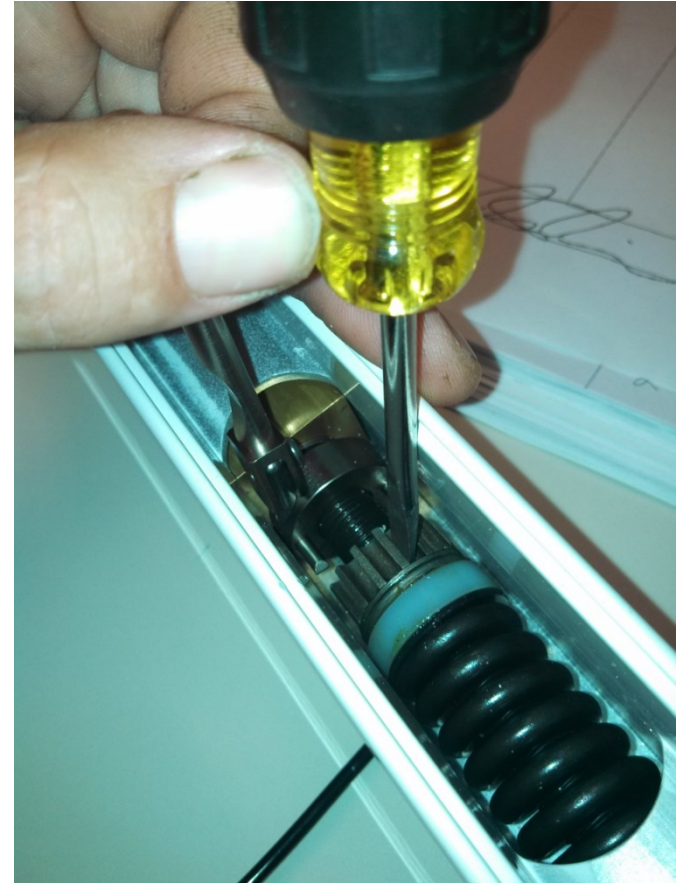
If the arm needs a lot of adjustment it is sometimes easier to use the following method.

Disengage the lever arm from the toothed nut.

Then using a screwdriver lever the toothed nut in the proper direction to tighten or loosen the spring assembly. Use caution to avoid damaging painted surfaces that will be exposed.
